DRIP SYSTEM MAINTENANCE & AERIAL IMAGING

"Drip system maintenance lengthens drip life & improves farm profitability"

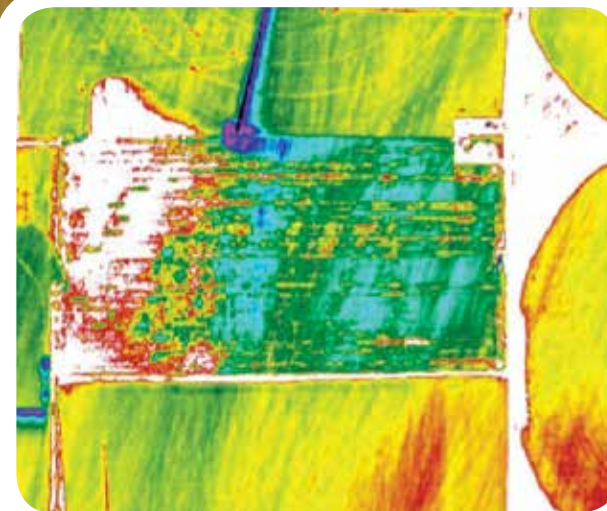
Figure 1: Thermal image taken 7/31/14 via Air Scout. The white coloration at the bottom end of the rectangular block indicates crop stress.

On July 31, 2014 aerial images (*Figure 1*) revealed white coloration on about 15 acres of Anthony's soybeans at the end of a rectangular 80 acre drip irrigated block. In a thermal ADVI image, white indicates crop stress, while green indicates normal crop health. Armed with GPS coordinates and his tablet device, Anthony and his staff walked through the area indicated in white to troubleshoot, but were unable to visually see a problem. So they started digging. Once they reached the buried driplines, it was evident that they were clogged and not emitting water. Later they discovered the clogging was a result of new bacteria that were recently detected in well water samples.

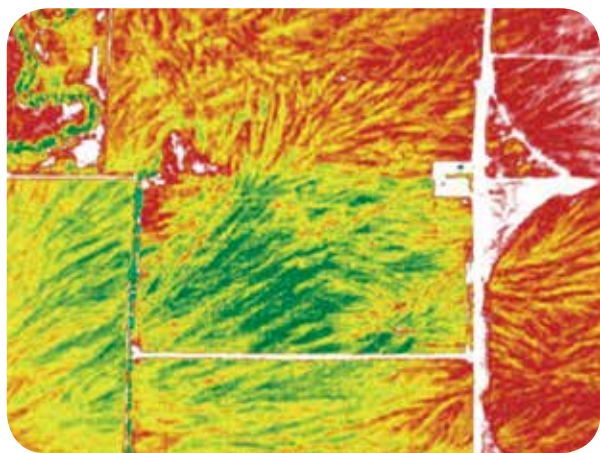
Figure 2: Thermal image taken 8/12/14 via Air Scout. The areas previously colored white on the rectangular drip irrigated field have mostly recovered.

On August 12th, aerial images (Figure 2) showed that the previously stressed area in white had turned mostly green, and by August 14th (Figure 3) the area was completely green, indicating normal, hydrated crop growth. The problem was solved.

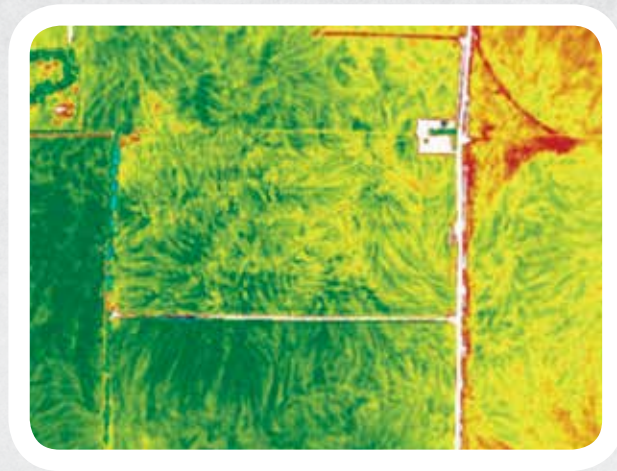
Figure 3: Thermal image taken 8/18/14 via Air Scout. The areas previously colored white on the rectangular drip irrigated field have completely recovered.
