Marketing Manager, Reelmaster Products
The Toro Company

Aftercut appearance, Part One: The science behind the art...

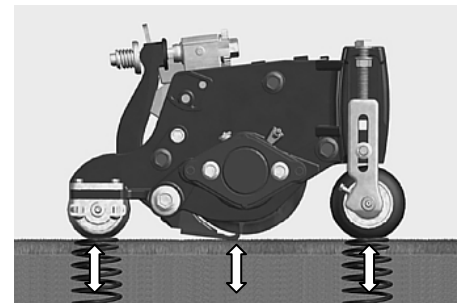
Soft turf with a low spring rate does not restabilize cutting units as quickly as firm turf does, so bobbing is more likely.

There is, however, a window in early spring when the turf comes out of dormancy, the soil is very soft, and the "spring rate" of the turf approaches the level needed to create bobbing of the cutting unit. *Spring rate* determines the distance the turf deflects under the weight of the cutting unit. The softer a turf is — the lower the spring rate — the longer it takes for the cutting unit to restabilize and stop bouncing.

On the other end of the spectrum, if the suspension is softer (lower spring rate) like a Cadillac, the tire will traverse through the bump, absorb some of the energy, and continue to bob or sway vertically long after the initial impact. This is how the cutting unit can become "excited" to the point where bobbing occurs and continues across a fairway.

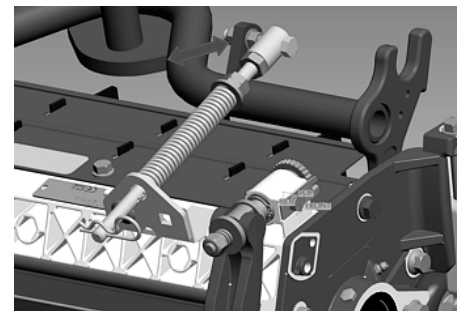
Under soft conditions, the turf compensation springs may need to be adjusted to shift more c/u weight to the rear roller.

To offset this variation in turf, Toro engineered a turf compensation spring to optimize front-to-rear weight bias of the cutting unit. This adjustment gives you the ability to aggressively follow undulations of a fairway during normal mowing conditions, and if needed, shift more of the cutting unit weight to the rear roller to reduce any bobbing that may occur during the growing season.

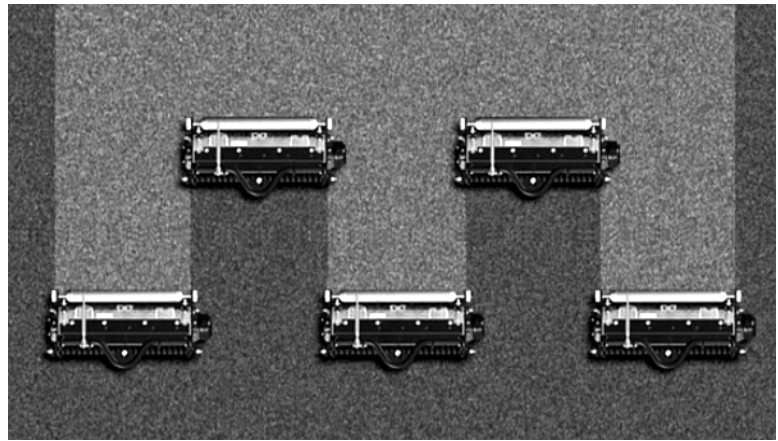
Wet or high-growth conditions may require special adjustment to ensure a uniform aftercut appearance across the full swath of the machine.

Under wet turf conditions, reel-to-reel setup consistency across the machine becomes more critical to ensure a uniform ACA. Issues that may occur if reels are not set up consistently include scalping, marking, step-cut and excess clippings, among many others. To compensate, most reel mowers have various roller options, adjustable counter balance springs, and most importantly HOC adjustment to allow you to achieve the same effective HOC in a variety of conditions.

To ensure your mower provides the desired ACA in wet conditions, it is most important to ensure all adjustments and attachments are set the same. If needed, it may help to switch to full rollers, add rear roller brushes, or increase the HOC setting.

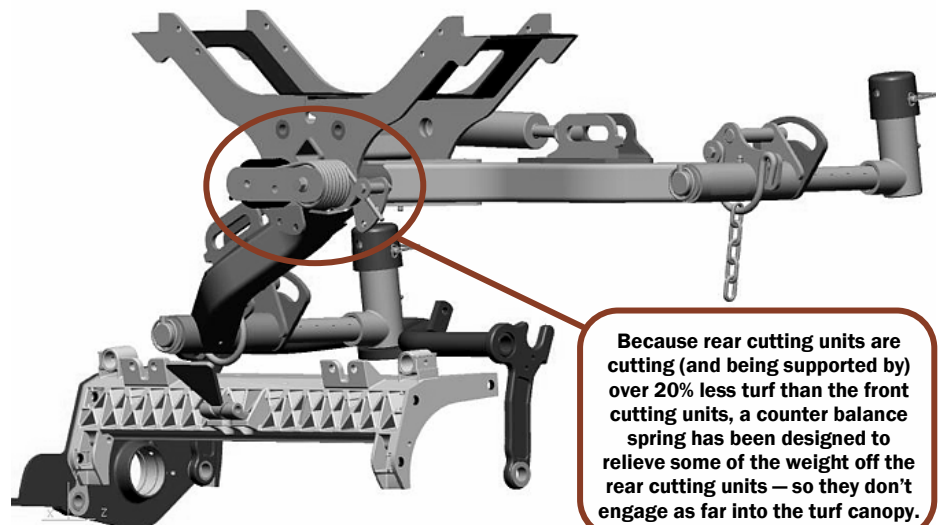
Because rear cutting units are cutting (and being supported by) over 20% less turf than the front cutting units, a counter balance spring has been designed to relieve some of the weight off the rear cutting units — so they don't engage as far into the turf canopy.

Now, let's address the fact that all cutting units have a certain amount of overlap between them to minimize uncut turf when turning or mowing on side hills. The Reelmaster 5010 series with 22" DPA cutting units, for instance, was designed with 2½" of overlap on each side of the cutting unit. This means the front three reels are exposed to a full 22" of thick, uncut turf canopy, while the rear two only see 17" of full turf canopy (and 5" of pre-cut turf). This is over 20% less full canopy pushing up on the rollers and bedknife, which in high growth

To compensate for this, Toro has designed in a simple counter-balance spring that can be set to relieve some of the weight off the rear two cutting units, thus reducing the difference between front and rear cutting units for a more uniform HOC and resulting ACA.

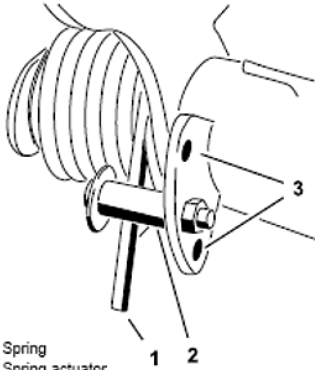
Each of four settings on the counterbalance springs increases or decreases counter-balance on the cutting unit by 5 lb. The springs can be positioned on the back side of the spring actuator to remove all counter balance (4th position).

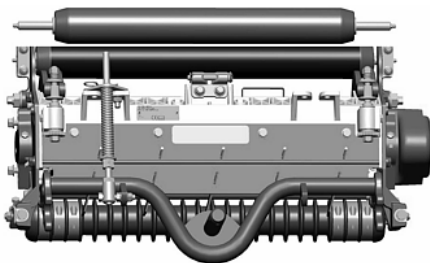
A top view of the Toro 5" DPA fairway cutting unit showing the full width rear roller (installed) with the now-standard shorter rear roller behind it.

Other ACA variations which can result from cutting unit overlap include *double roll* marks and *double cut* marks. Each has its own unique visual appearance and typically shows up as small (2" or less) strip between each cutting unit. To compensate for these, Toro developed shorter rear rollers (standard on 5" dia. cutting units) to eliminate the double roller marks most often seen in cool season grasses.
